## 動力刀異音 Abnormal sound at driven tool

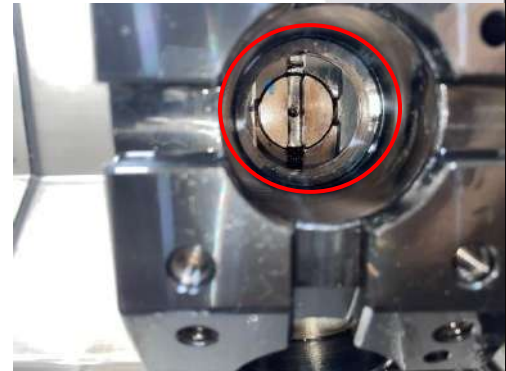
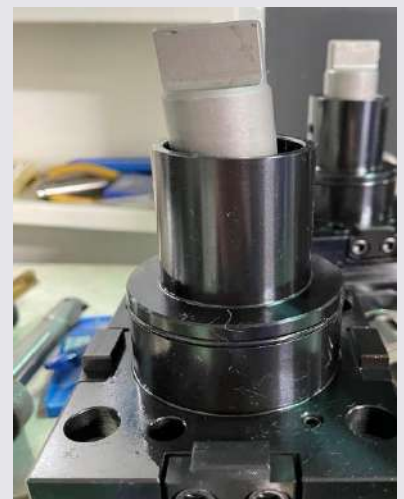
刀座耦合齒示意圖

圖示(一):

齒輪頭耦合齒在原點狀態下才可作換刀及旋轉之動作

Tool drive in zero - position.  
Rotating or indexing is possible.

圖示(二):

齒輪頭耦合齒沒在原點狀態下不可作換刀及旋轉之動作

Tool drive not in zero - position.  
Rotating or indexing is not possible.

圖示(三):

齒輪頭耦合齒在原點狀態下，但齒輪頭位移不可作換刀及旋轉之動作

Fault case.  
Turret in inter position.

齒輪頭耦合齒必須與刀盤孔同心並和導軌成平行

Only do indexing and rotating when gear head coupling is at zero position.
