## 齒輪箱異音

### Abnormal sound in Gearbox

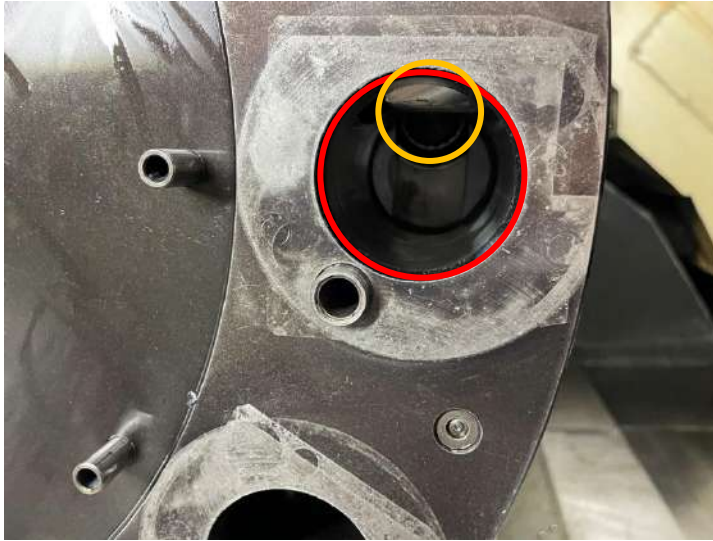
1. 刀塔撞車後造成刀盤或耦合齒中心位置偏移

Tool disc or center of coupling might be off-position because of crash.

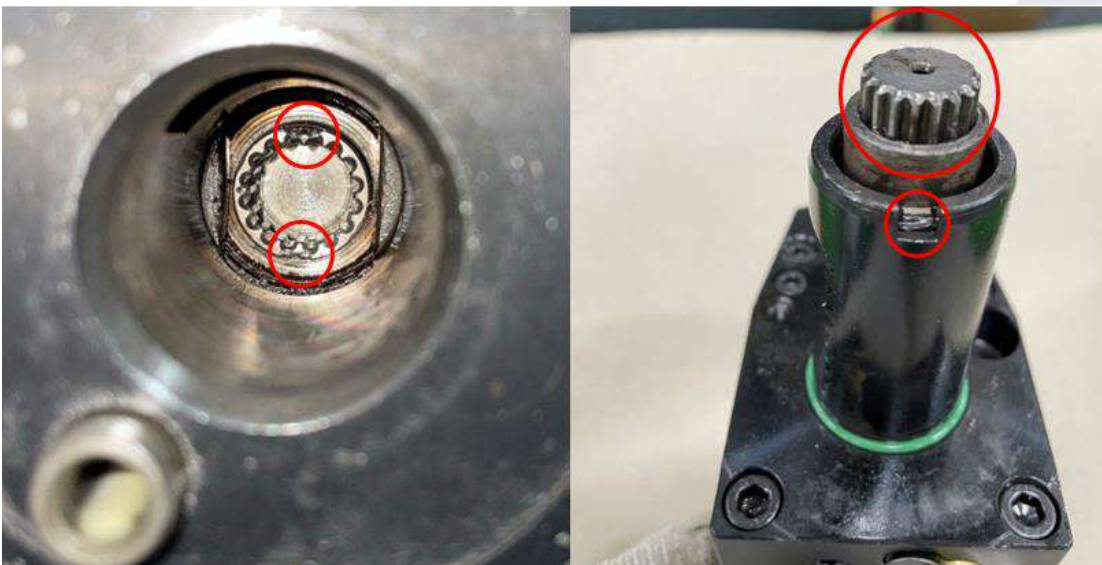
2. 確認刀塔端及動力刀座耦合齒是否受損？

Check whether the turret coupling and the live tool holder coupling are damaged or not ?

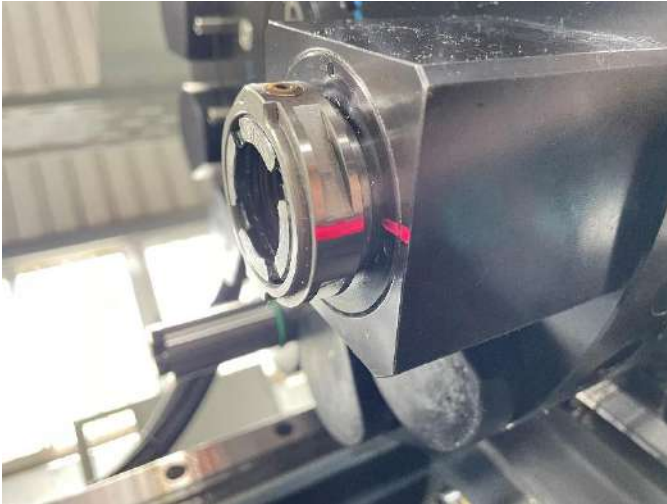
3. 確認耦合齒結合順暢，耦合時動力刀座是否扭刀嚴重

Check if couplings are connected smoothly, and whether live tool holder moves severely when coupling.
