漏水檢查 Coolant Leakage Check

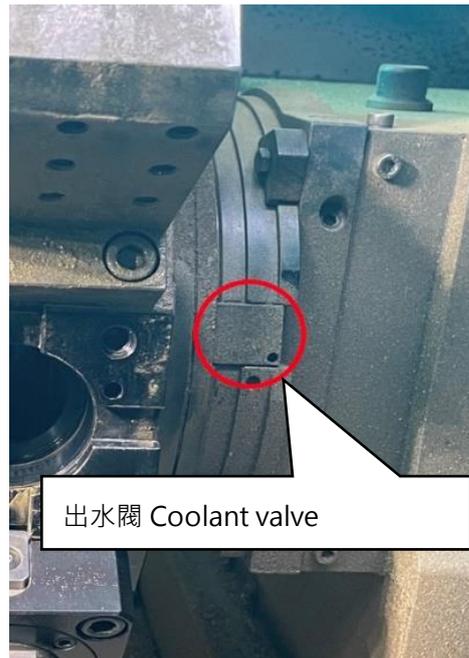
1. 檢查出水閥是否表面磨耗不平整。依據噴水塊組更換步驟清潔出水閥，檢查異物並重新推磨出水閥或更換。後續加強過濾，定期清潔切削液水箱。

Check whether the coolant valve is worn out and uneven. Follow the steps on "Replacement and cleaning of coolant valve". Clean the coolant valve or replace with a new one. Ensure the filter grade meets required standard, and perform coolant tank cleaning on regular basis.

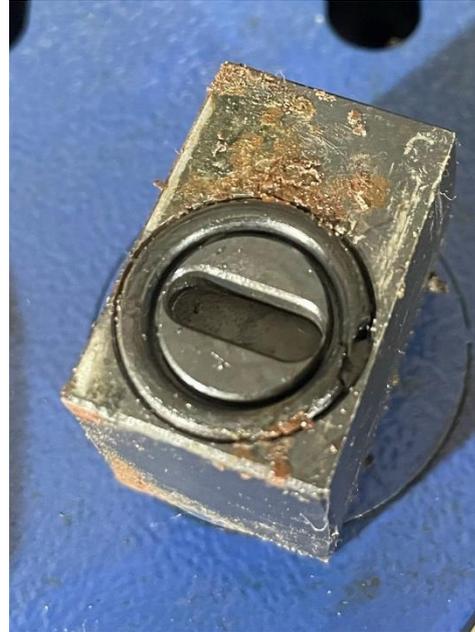
2. 在噴水環另一側有擋水塊，可從刀塔後方檢查有無漏水並更換 Oring。

There is a water block located on the other side of the coolant ring.

You may observe whether there is any leakage from the rear side of

the turret. Replace with a new O-ring when necessary.

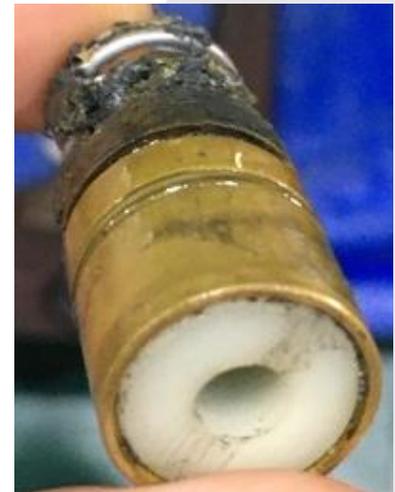
3. 檢查機床切削液壓力是否過大，調整壓力。

Check whether the coolant pressure is too high,
adjust the pressure accordingly.
