漏水檢查 Coolant Leakage Check

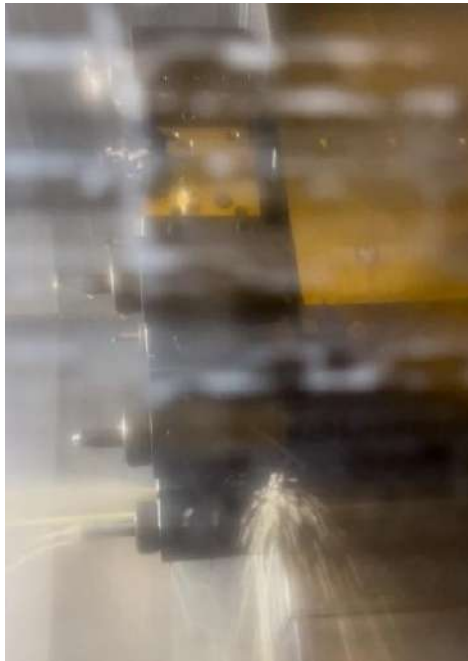
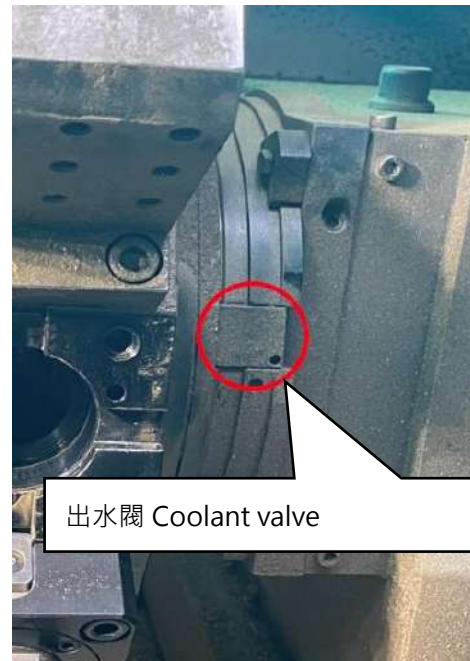
1. 檢查出水閥是否表面磨耗不平整。依據噴水塊組更換步驟清潔出水閥，檢查異物並重新推磨出水閥或更換。後續加強過濾，定期清潔切削液水箱。

Check whether the coolant valve is worn out and uneven. Follow the steps on "Replacement and cleaning of coolant valve". Clean the coolant valve or replace with a new one. Ensure the filter grade meets required standard, and perform coolant tank cleaning on regular basis.

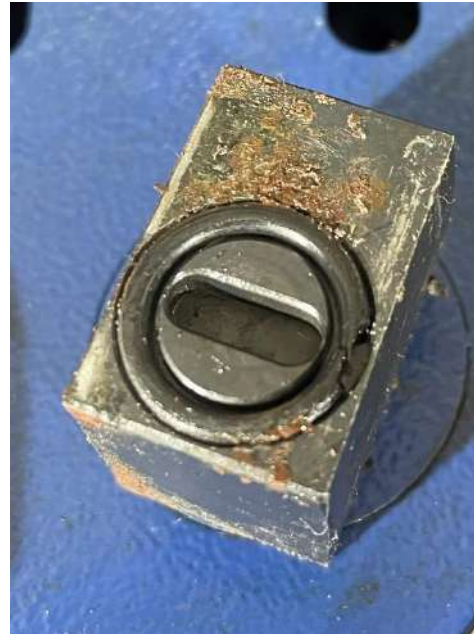
2. 在噴水環另一側有擋水塊，可從刀塔後方檢查有無漏水並更換 Oring。

There is a water block located on the other side of the coolant ring.

You may observe whether there is any leakage from the rear side of

the turret. Replace with a new O-ring when necessary.

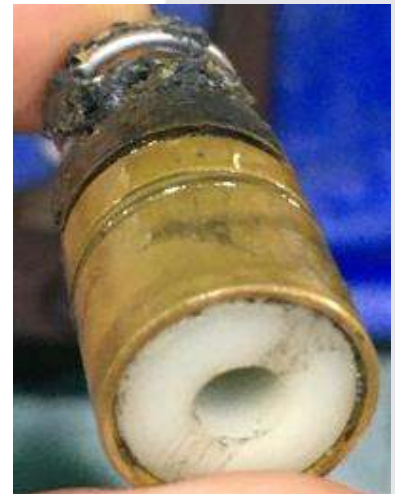
3. 檢查機床切削液壓力是否過大，調整壓力。

Check whether the coolant pressure is too high,
adjust the pressure accordingly.
