## VDI 徑向刀塔無法換刀或定位

### VDI Radial mount turret is unable to index or position

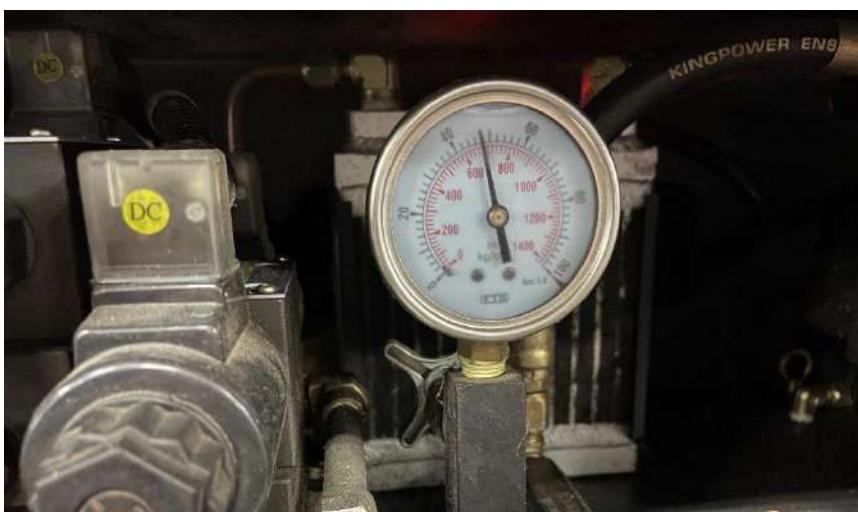
1. 檢查刀塔放鬆夾緊是否正常，油壓是否 50KG 。

Check if hydraulic pressure is at 50kgs, and whether turret operates normally while doing clamp and unclamp.

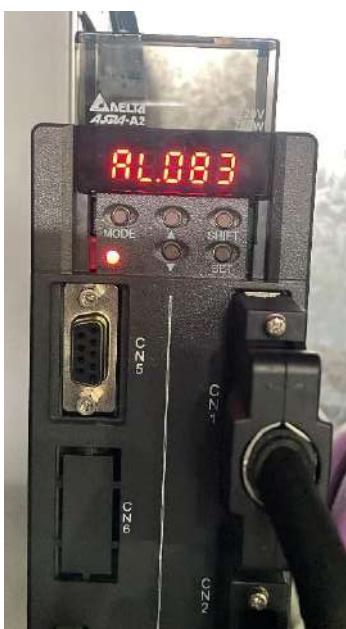
2. 檢查刀塔驅動器是否有異警碼

Check if there is any error code shown on drive unit display.

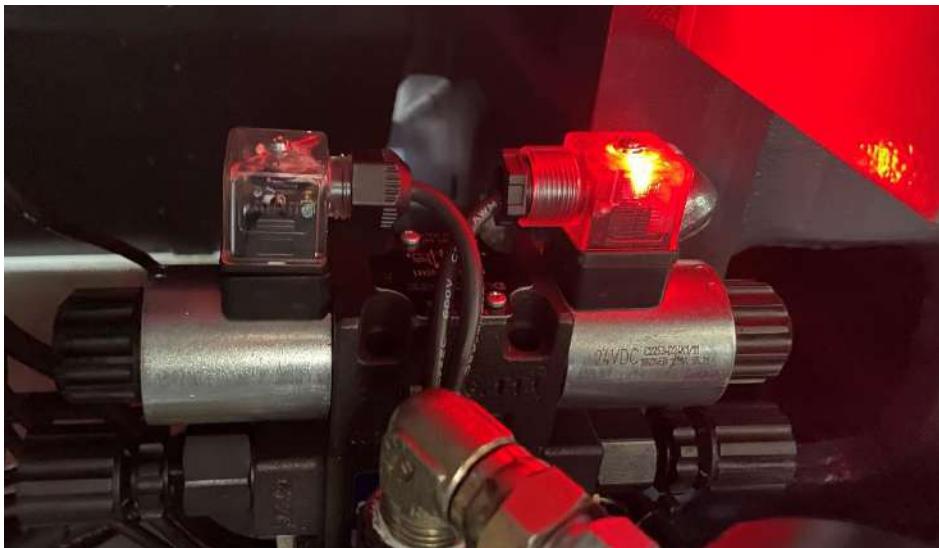
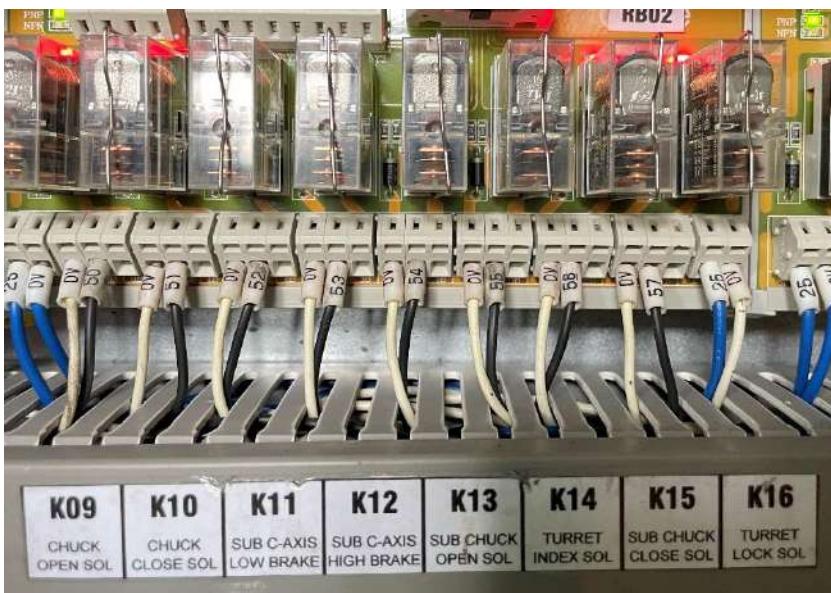
3. 檢查是否油壓電磁閥、繼電器燒毀或接觸不良 、節流閥流量是否過小。

Check if hydraulic pressure solenoid valve and relay are well connected

and no burn out. Also check if throttle flow is too small ?

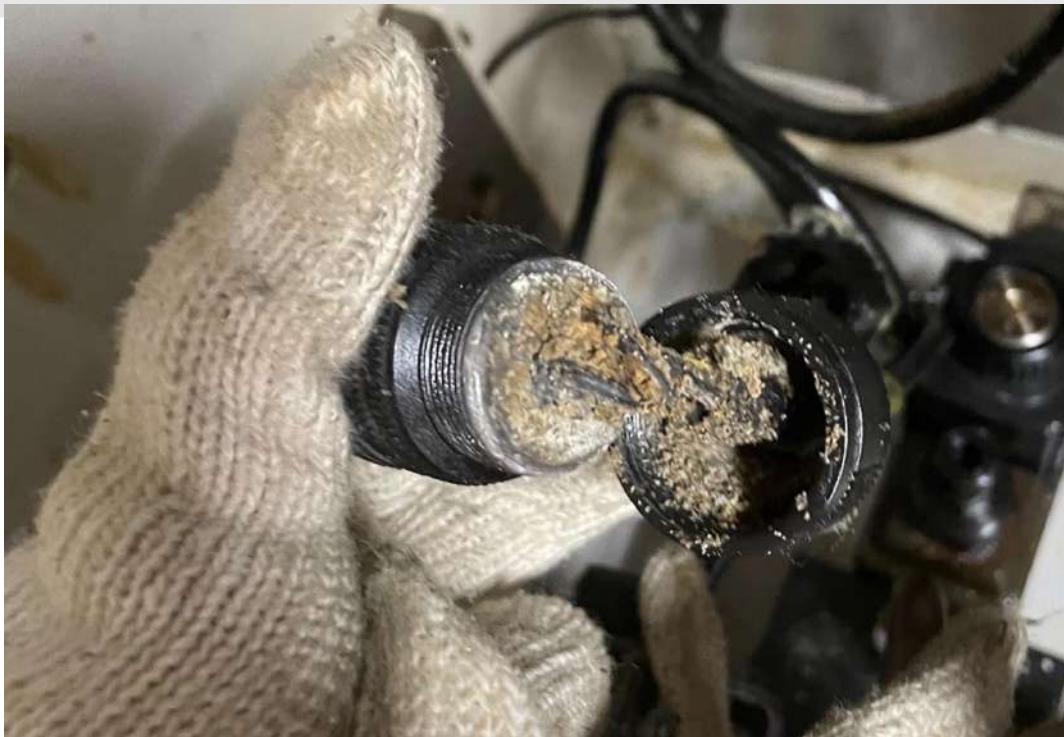
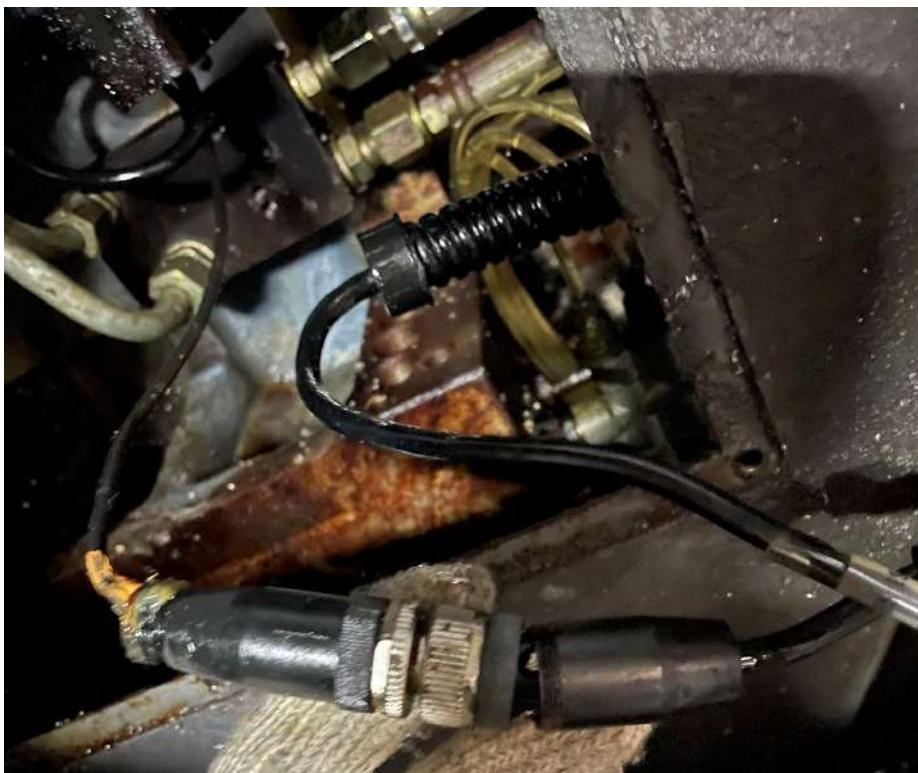
4. 檢查刀塔端各動力、編碼器、近接開關接頭線路是否鬆脫或進水 。

Check whether all cable lines of tool drive motor, encoder, and proximity

switch connectors are well connected and no water ingress.

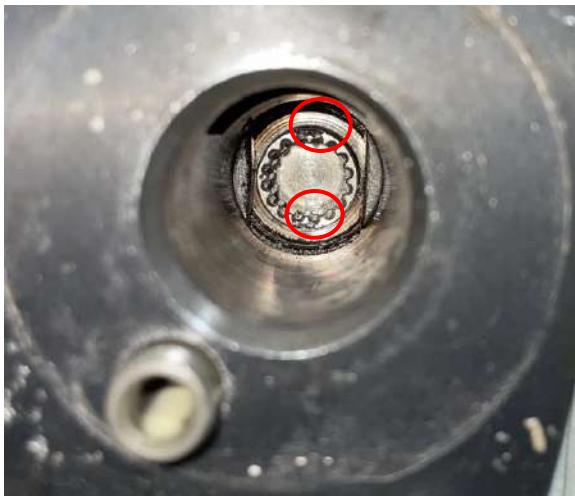
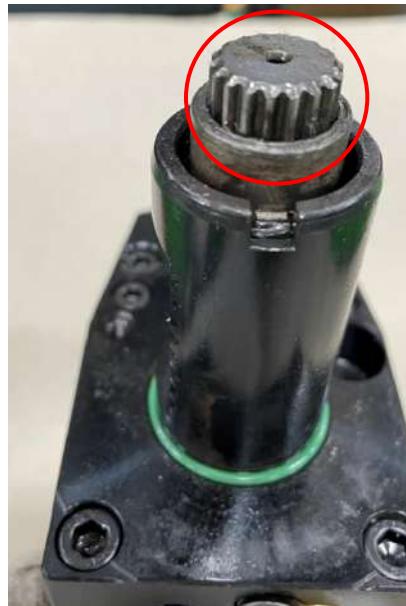
8. 檢查動力刀座及刀塔耦合齒是否損壞，無法耦合。

Check whether couplings on turret and the driven tool holder are intact without damages.

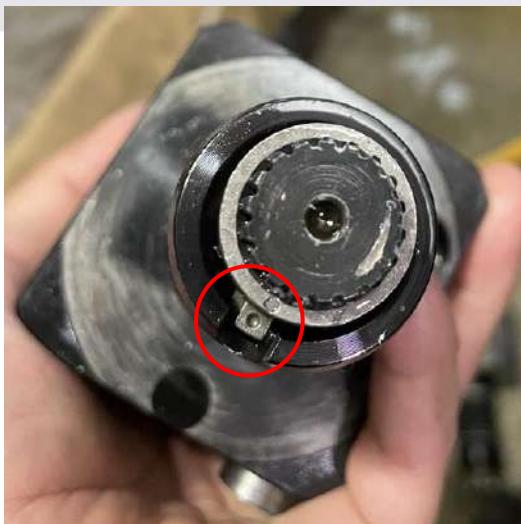
9. 刀座安裝前需先手動定位，定位時確認刀座無法轉動。

Driven tool holder needs to be manually positioned before installation.

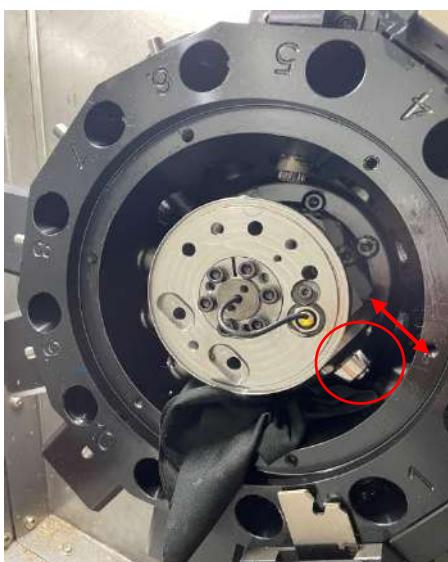
10. 把加工刀位的刀座移除後，檢查刀塔夾緊放鬆，檢查耦合齒油壓缸前後作動是否正常。

Remove the tool holder on the working position. Clamp and unclamp the turret to confirm it works normally. Check if the moves of coupling hydraulic cylinder is normal.

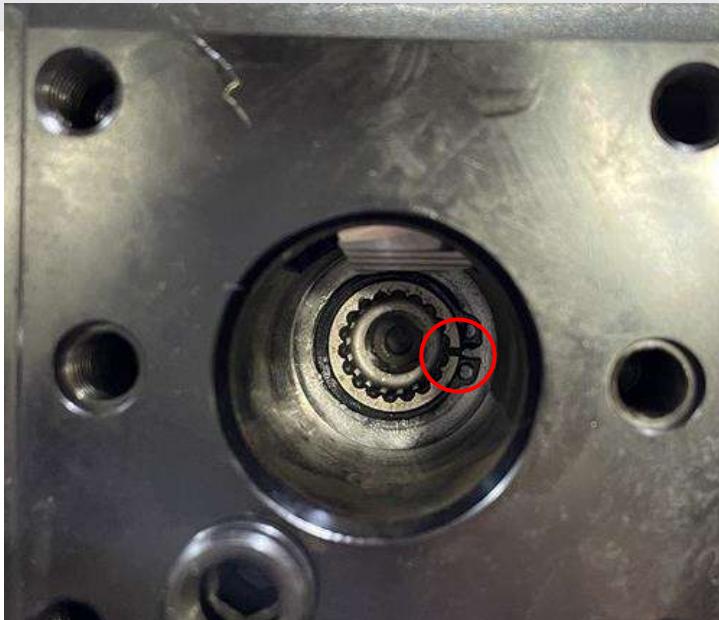
11. 檢查刀塔耦合齒原點是否在 3 點鐘位置

Check if turret coupling origin is at 3 o' clock.

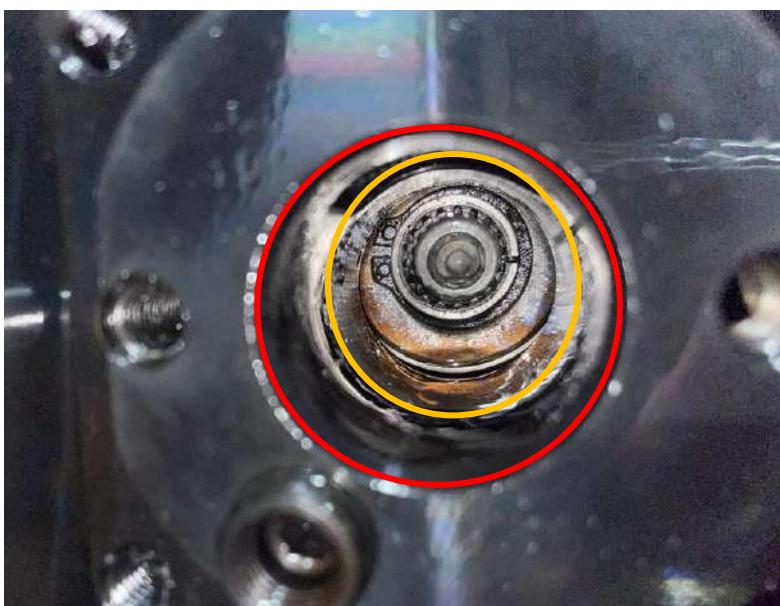
12. 刀塔撞車後造成刀盤或耦合齒中心位置偏移。

Centers of the tool disc and coupling might be off-position when a crash happened.

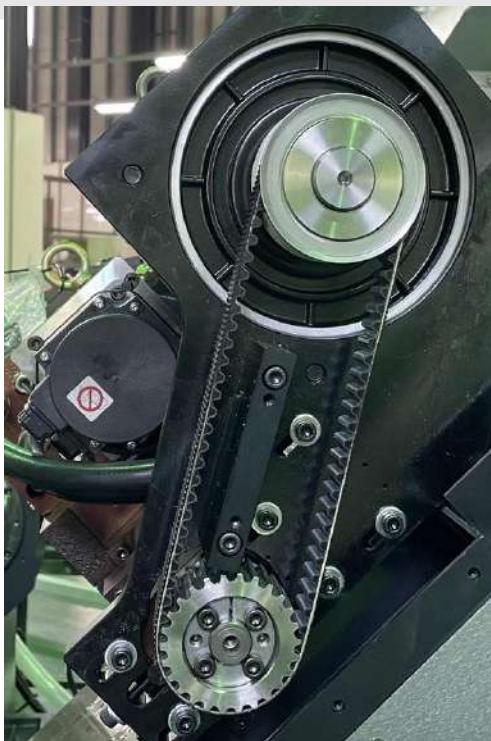
13. 動力 U 型皮帶式，請檢查皮帶是否斷裂

For tool drive motor with U connection: check if the belt is intact without breakage.

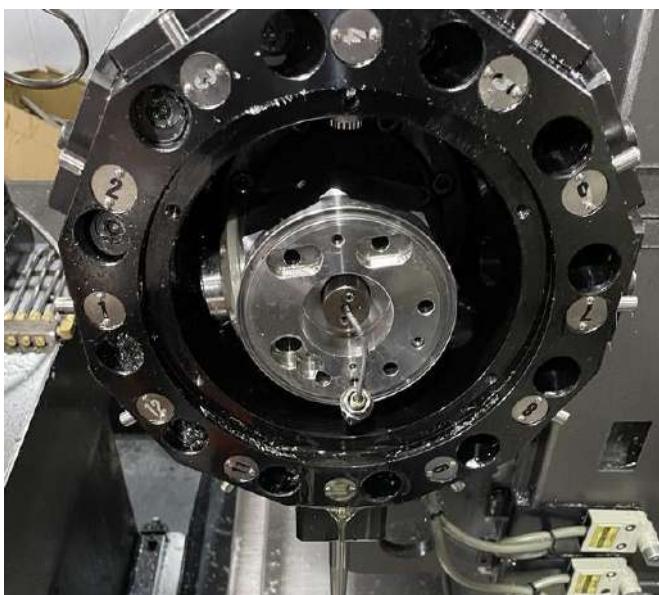
14.齒輪頭內部零件損壞卡死無法運轉。

Internal parts of the gearbox are damaged and stuck and cannot operate
